# THE EARLY SKYMASTER STORY

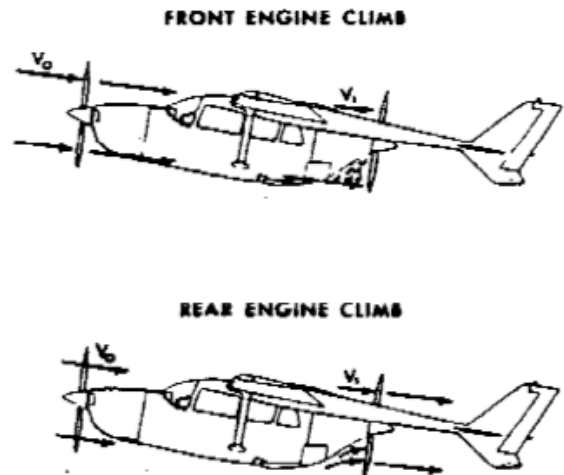
Fig. 1 — Propeller inflow and slipstream effects in single-engine climb

As we prepare for the first flight, everyone was taking bets on which engine would give the best engine-out climb. Dave Bierman, chief engineer at Hartzell Propeller Company (and former longtime aerodynamics research engineer at NACA) put his money on the rear engine. He explained "The rear engine propeller has no blockage behind it, its diameter is two inches greater, its inflow velocity is favorably reduced, and it promotes better airflow attachment to the bluff afterbody of the rear cowl" as illustrated in figure 1. Later he proved to be right and collected the doubters' money! Test results showed the rear engine to have a 24% rate-of-climb advantage over the front engine only operation.

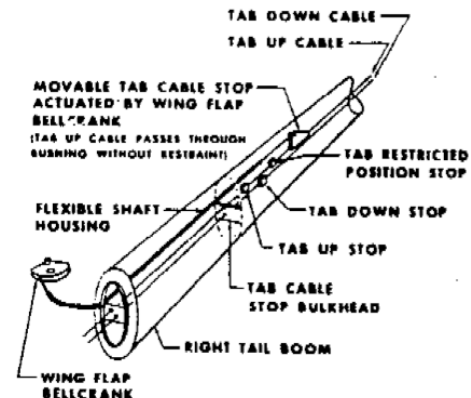
Fig. 2.- Elevator trim/wing flap interconnect system

We also looked for an interconnect system that would automatically change the trim tab setting as the flaps were extended and retracted electrically. Bill Seidel, assistant project engineer, designed a clever device that "semi-automatically" reduced very heavy out-of-trim elevator forces in balked landing climb-outs when the flaps were retracted as illustrated in Figure 2. The progression of elevator stick force changed from a landing configuration glide to a balked-landing-climb and, finally, to a flaps-retracted climb is illustrated graphically in Figure 3. As power is applied, the nose-up trim must be counteracted by a 40-pound push force. Then as flaps are retracted (removing a powerful nose-down pitching moment) an additional push force up to 80-pound is required to maintain the original trim speed. This test increment of push force was eliminated very neatly by Bill's invention. The elevator trim tab cables are routed down the right tail boom. A

flexible shaft connects to one arm of the wing flap bellcrank and engages a swaged ball on the tab cable during part of its travel. With flaps retracted, the pilot can trim the elevator tab to no more than 10 degrees with flaps extended, the flexible shaft moves aft, permitting additional manual adjustment of the tab to 26 degrees. Conversely, when the flaps are retracted electrically from 30 to 15 degrees, the flexible shaft automatically drags the tab cable from the original position to 10 degrees. This relieves the out of trim force to 20-pounds as shown in the aforementioned graph. In addition, it relieves the pilot from manually making large trim wheel rotations during this period of high activity by the pilot.

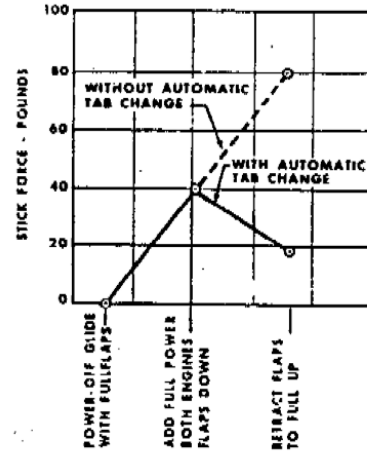
Fig. 3 - Longitudinal trim changes in bailed landing go-around

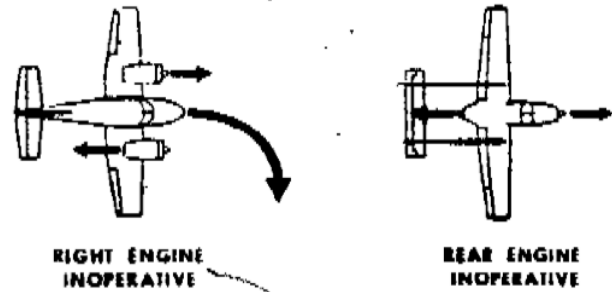
Fig. 4 - Effect of engine failure on directional control

Sketches of the thrust/drag vectors with an engine out are shown in Figure 4 with comparative take off profiles and graphical comparisons of total take-off distances in Figures 5 through 8. The flight path shown by the solid line in Figure 5 indicates the normal twin-engine climb-out path, and the dotted lines represent (schematically) two possible flight paths with an engine failure.

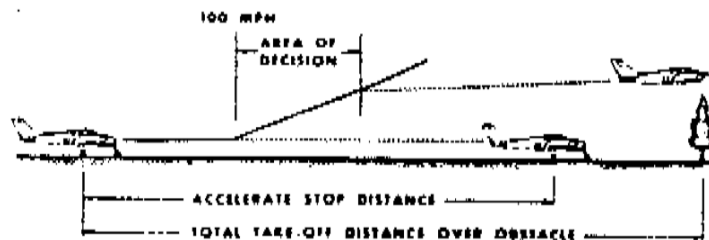
Fig. 5 - Single engine take-off - conventional twin

1. The conventional twin will yaw sharply in the direction of the failed engine, and if the speed is below  $V_{mc}$  it will also roll in that direction.
2. Counteract yaw and roll with full opposite rudder and partial opposite aileron while maintaining at least  $V_{mc}$  speed and a constant heading.
3. Decide whether to terminate or continue the take off. Assuming that the take off is to be continued, retract the landing gear.
4. Identify the failed engine, remembering that "idle foot identifies idle engine".
5. Feather the windmilling propeller.
6. Trim the rudder tab to counteract asymmetric thrust.
7. Accelerate to  $V_y$  climb speed (or  $V_x$  speed with obstructions ahead).
8. Climb over any obstructions at the end of the field.

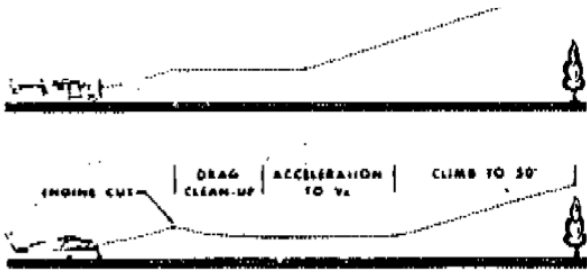
Fig. 6 - Take-off profile with engine cut at  $1.2 V_s$

In comparing the last two take-off profiles, one can see that the CLT twin's engine-out take-off distance advantage is amplified as the airspeed at engine cut is reduced from  $1.2 V_s$  to  $1.1 V_s$  in this case the conventional twin has no alternative but to discontinue the take-off because the engine cut occurs at an airspeed lower than minimum control speed ( $V_{mc}$ ). In contrast, the CLT airplane is able to continue with the take-off since its  $V_x$  speed is very close to the  $1.1 V_s$  speed. These comparisons are illustrated convincingly in Figure 8, showing numerical distances as a function of engine-out speed.

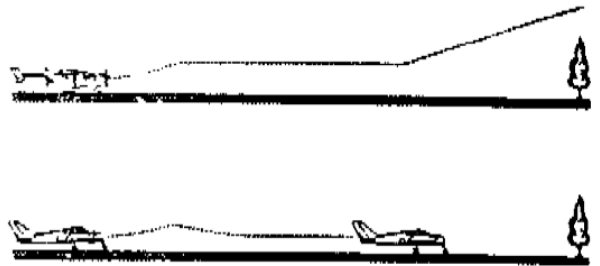
Fig. 7 - Take-off profile with engine cut at  $1.1 V_s$

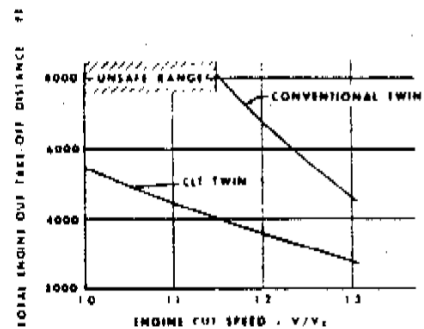
Fig. 8 - Effect of engine cut speed on total take-off distance over 50 ft obstacle

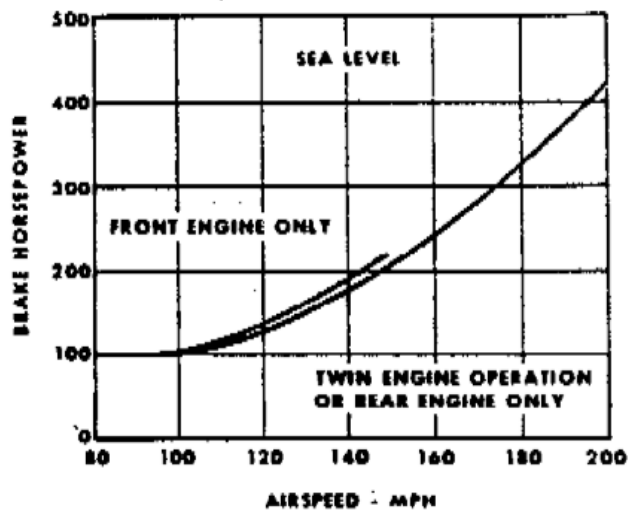
Fig. 10 - Effect of front or rear engine operation on speed-power

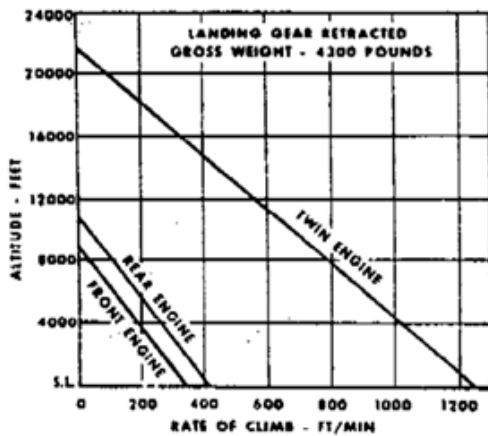
Fig. 11 - Rate of climb versus altitude

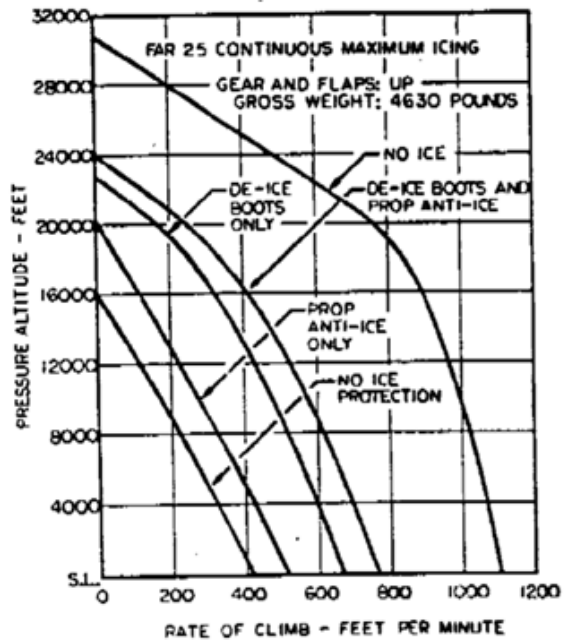
Fig. 12 - Icing climb performance decrements for Super Skyman
