THE EARLY SKYMASTER STORY

Once again, Don Ahrens was asked to head up the project that would start with the C-336 and eventually become the Cessna 337, with help from the aerodynamics, power plant, structure, and electrical groups. Had we had the foresight to anticipate a retractable landing gear addition years later (in the C-337) we might have selected a lowing configuration. In hindsight, this would have made a more attractive airplane and it would have been much more adaptable to a retractable landing gear. However, it seemed natural to go with a high-wing version for the benefits of better stability, gravity flow fuel system, and shelter from the elements while enplaning and deplaning. To keep this rather top-heavy airplane as low as possible, we also dismissed the idea of a downward-sloping nose so typical of our single-engine models. This later proved unwise as the airplane appeared to cruise nose-high. In later versions the wing incidence and cowl shape were modified to improve over-the-nose visibility.

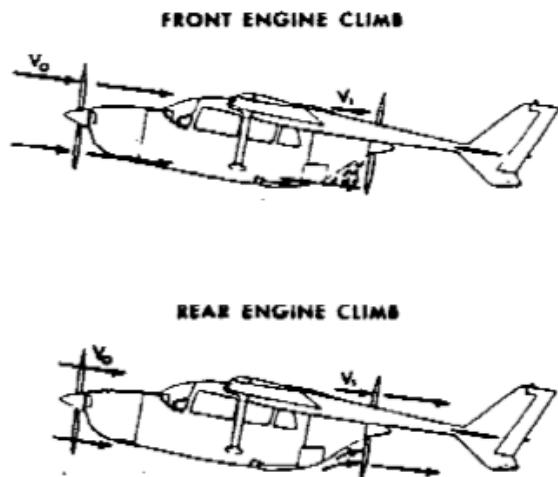
Fig. 1 — Propeller inflow and slipstream effects in single-engine climb

As we prepare for the first flight, everyone was taking bets on which engine would give the best engine-out climb. Dave Bierman, chief engineer at Hartzell Propeller Company (and former longtime aerodynamics research engineer at NACA) put his money on the rear engine. He explained "The rear engine propeller has no blockage behind it, its diameter is two inches greater, its inflow velocity is favorably reduced, and it promotes better airflow attachment to the bluff afterbody of the rear cowl" as illustrated in figure 1. Later he proved to be right and collected the doubters' money! Test results showed the rear engine to have a 24% rate-of-climb advantage over the front engine only operation.

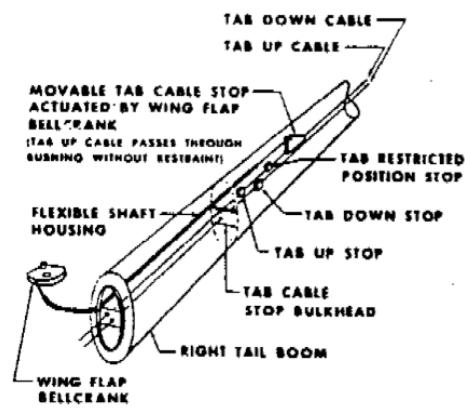
Fig. 2 - Elevator trim/wing flap interconnect system

We also looked for an interconnect system that would automatically change the trim tab setting as the flaps were extended and retracted electrically. Bill Seidel, assistant project engineer, designed a clever device that "semi-automatically" reduced very heavy out-of-trim elevator forces in balked landing climb-outs when the flaps were retracted as illustrated in Figure 2. The progression of elevator stick force changed from a landing configuration glide to a balked-landing-climb and, finally, to a flaps-retracted climb is illustrated graphically in Figure 3. As power is applied, the nose-up trim must be counteracted by a 40-pound push force. Then as flaps are retracted (removing a powerful nose-down pitching moment) an additional push force up to 80-pound is required to maintain the original trim speed. This test increment of push force was eliminated very neatly by Bill's invention. The elevator trim tab cables are routed down the right tail boom. A

flexible shaft connects to one arm of the wing flap bellcrank and engages a swaged ball on the tab cable during part of its travel. With flaps retracted, the pilot can trim the elevator tab to no more than 10 degrees with flaps extended, the flexible shaft moves aft, permitting additional manual adjustment of the tab to 26 degrees. Conversely, when the flaps are retracted electrically from 30 to 15 degrees, the flexible shaft automatically drags the tab cable from the original position to 10 degrees. This relieves the out of trim force to 20-pounds as shown in the aforementioned graph. In addition, it relieves the pilot from manually making large trim wheel rotations during this period of high activity by the pilot.

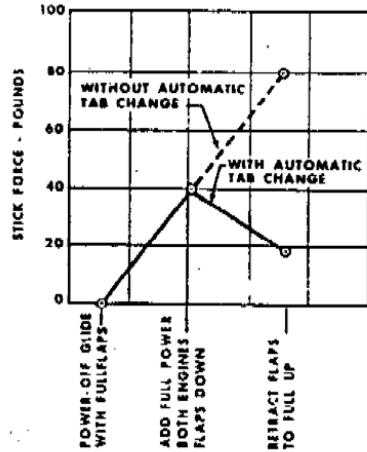
Fig. 3 - Longitudinal trim changes in balked landing go-around

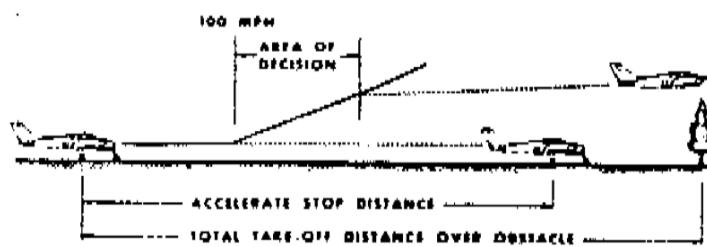
Fig. 5 - Single engine take-off - conventional twin

1. The conventional twin will yaw sharply in the direction of the failed engine, and if the speed is below V_{mc} it will also roll in that direction.
2. Counteract yaw and roll with full opposite rudder and partial opposite aileron while maintaining at least V_{mc} speed and a constant heading.
3. Decide whether to terminate or continue the take off. Assuming that the take off is to be continued, retract the landing gear.
4. Identify the failed engine, remembering that "idle foot identifies idle engine".
5. Feather the windmilling propeller.
6. Trim the rudder tab to counteract asymmetric thrust.
7. Accelerate to V_y climb speed (or V_x speed with obstructions ahead).
8. Climb over any obstructions at the end of the field.

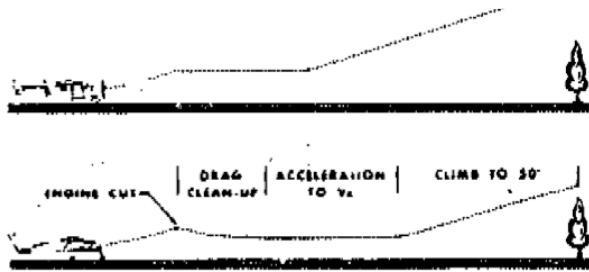
Fig. 6 - Take-off profile with engine cut at $1.2 V_x$

In comparing the last two take-off profiles, one can see that the CLT twin's engine-out take-off distance advantage is amplified as the airspeed at engine cut is reduced from $1.2 V_x$ to $1.1 V_x$. In this case the conventional twin has no alternative but to discontinue the take-off because the engine cut occurs at an airspeed lower than minimum control speed (V_{mc}). In contrast, the CLT airplane is able to continue with the take-off since its V_x speed is very close to the $1.1 V_x$ speed. These comparisons are illustrated convincingly in Figure 8, showing numerical distances as a function of engine-out speed.

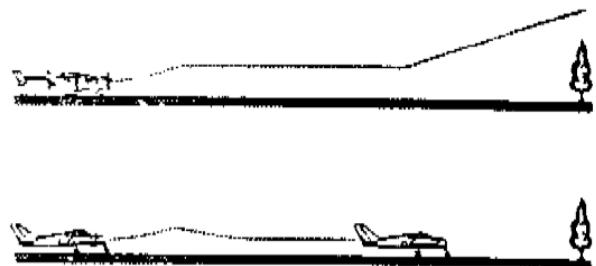
Fig. 7 - Take-off profile with engine cut at $1.1 V_x$

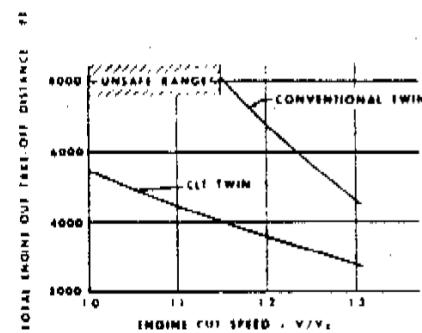
Fig. 8 - Effect of engine cut speed on total take-off distance over 50 ft obstacle

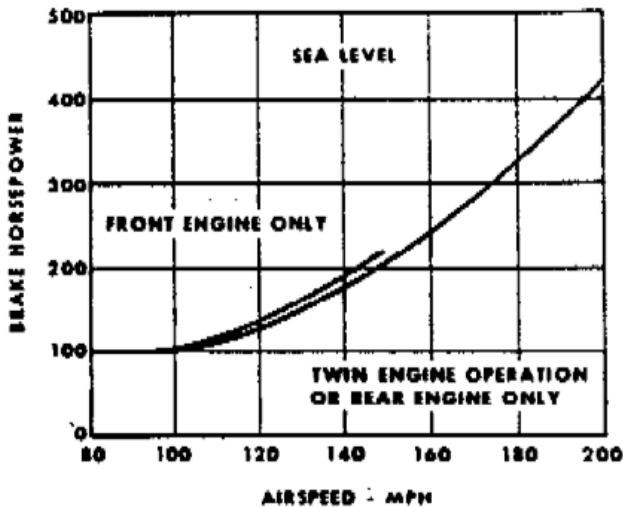
Fig. 10 - Effect of front or rear engine operation on speed-power

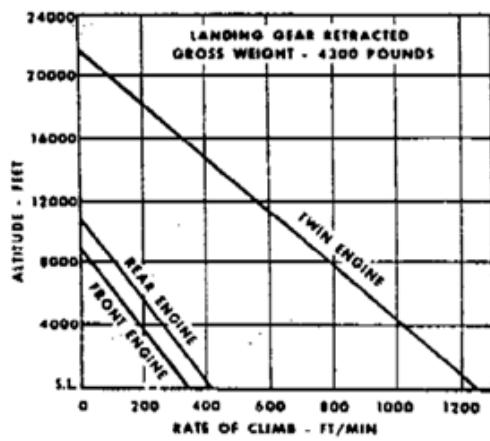
Fig. 11 - Rate of climb versus altitude

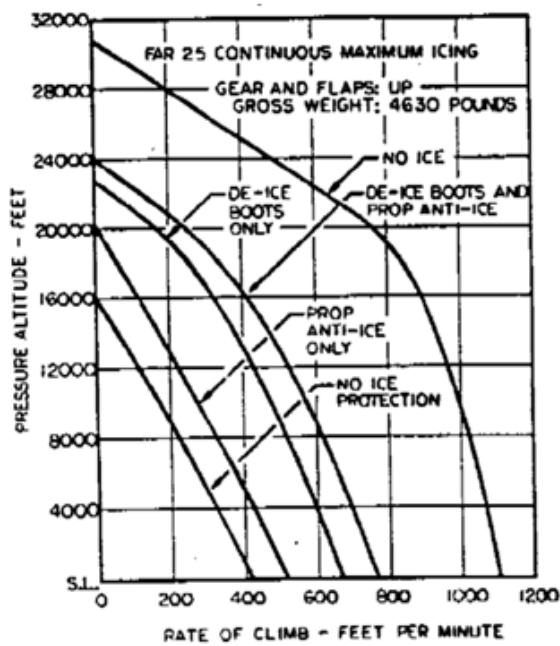
Fig. 12 - Icing climb performance decrements for Super Skymaster
